1. Introduction

In early March 2002, during inspections at the Davis-Besse (D-B) nuclear power station in response to NRC Bulletin 2001-01,¹ boric acid crystal deposits and iron oxide were observed at several openings in the lower service structure support skirt. Follow-up non-destructive examination (NDE) identified axial cracks in five control rod drive mechanism (CRDM) nozzles near the J-groove weld.² These cracks had initiated from the inner diameter (ID) of the nozzle and were attributed to primary water stress corrosion cracking (PWSCC). Three of these CRDM nozzles (#1, #2, and #3), located near the center of the reactor pressure vessel (RPV) head, contained through-wall cracks. In addition to the axial cracks CRDM nozzle #2 contained a circumferential crack that had initiated from the outer diameter (OD) of the nozzle.

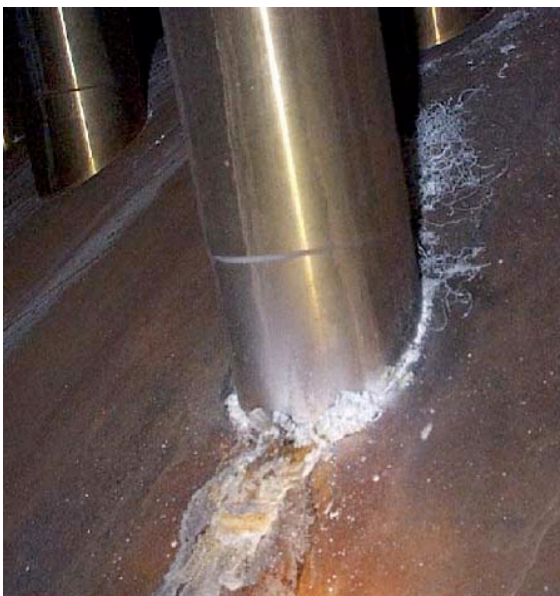
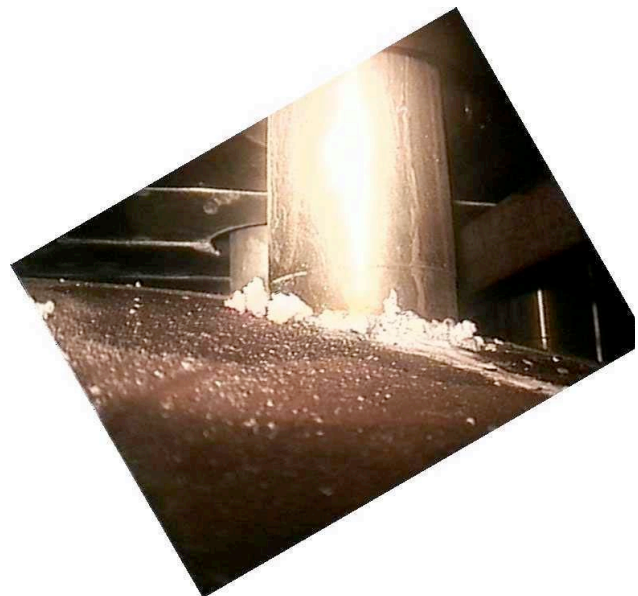
Figure 4. Deposits of boric acid crystals on reactor pressure vessel head from leaking CRDM nozzles.

acid deposits from leaking CRDM nozzles are shown in Fig. 4. In contrast to other plants with leaking nozzles, the boric acid deposits on top of the D-B RPV head from leakage from CRDM flange joints could have acted as an "incubator" wherein leaking borated water is retained under the deposits. The identity of the boric acid species within the annular enclave is speculative and could have ranged from aqueous, concentrated solutions of boric acid to molten mixtures of boric acid and boric oxide. The oxygen content of the solution was presumably low, due to the limited access through the annular gap, coupled with the probable egress of superheated steam through the same gap and an uphill pressure gradient.
